**SUMMARY REPORT OF FINDINGS**

**PHASE I ENVIRONMENTAL  
SITE ASSESSMENT**

**PROPOSED McDONALD'S REBUILD #29-0019**

**4295 & 4299 U.S. ROUTE 130**

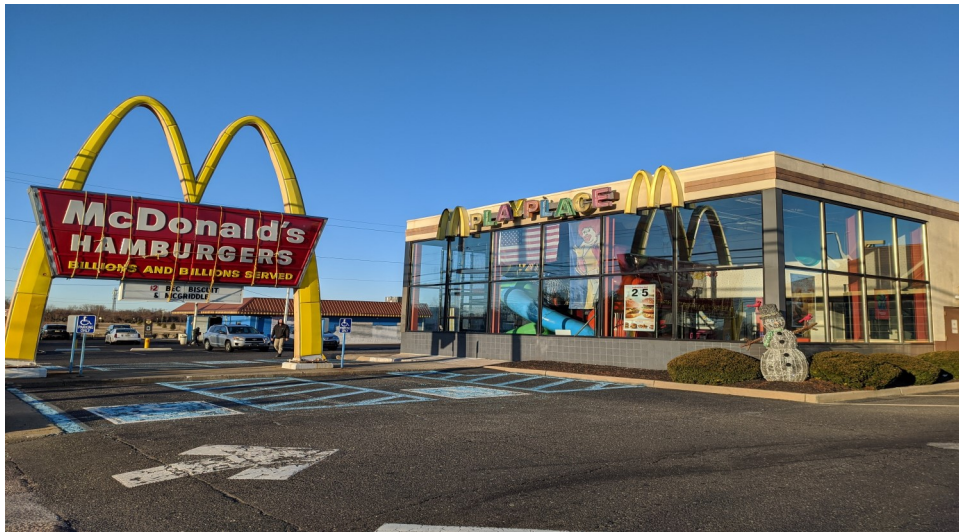
**SITE STRUCTURE, VIEW TO THE WEST.**

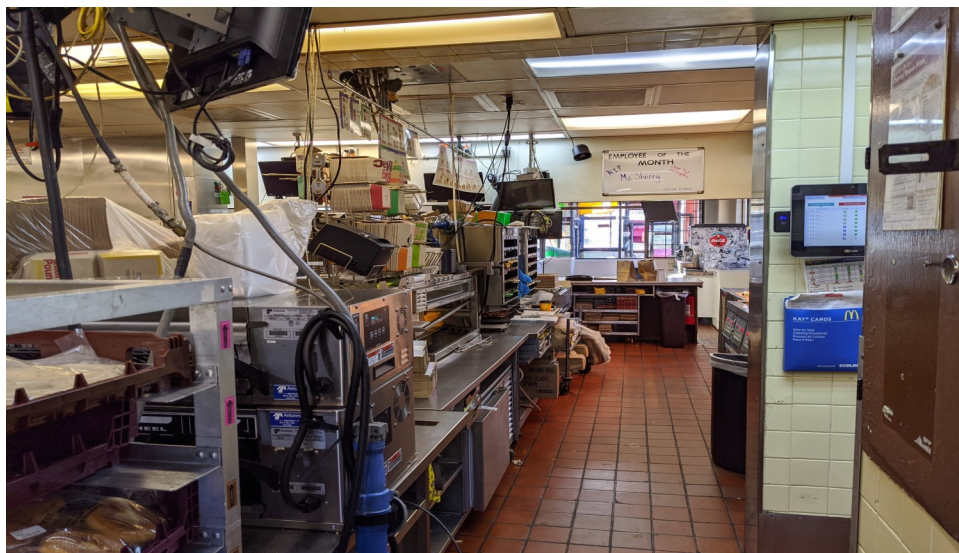
One approximately 200-gallon used cooking oil AST and one approximately 200-gallon virgin cooking oil AST were observed in the site structure during Whitestone's site reconnaissance. The ASTs are connected to a system that transports new and used fryer oil from the vessels to the kitchen area. The vessels are filled or emptied on an as-needed basis. The ASTs appeared to be used in an environmentally sound fashion with no evidence of release.

**SITE STRUCTURE, KITCHEN INTERIOR.**

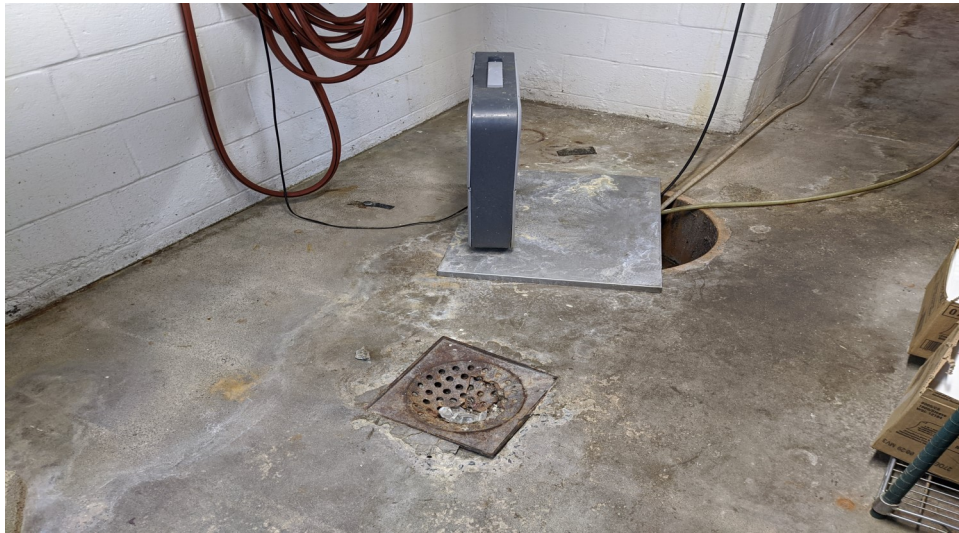
During Whitestone's site reconnaissance, one sump was observed in the basement of the site structure that most likely discharges to the sanitary sewer system. No evidence of staining was observed in the vicinity of this sump.

During Whitestone's site reconnaissance, several floor drains observed in the kitchen and in the bathrooms of the building that most likely discharge to the sanitary sewer system. No evidence of staining was observed in the vicinities of these floor drains.

**SUMP AND FLOOR DRAIN, SITE STRUCTURE BASEMENT.**

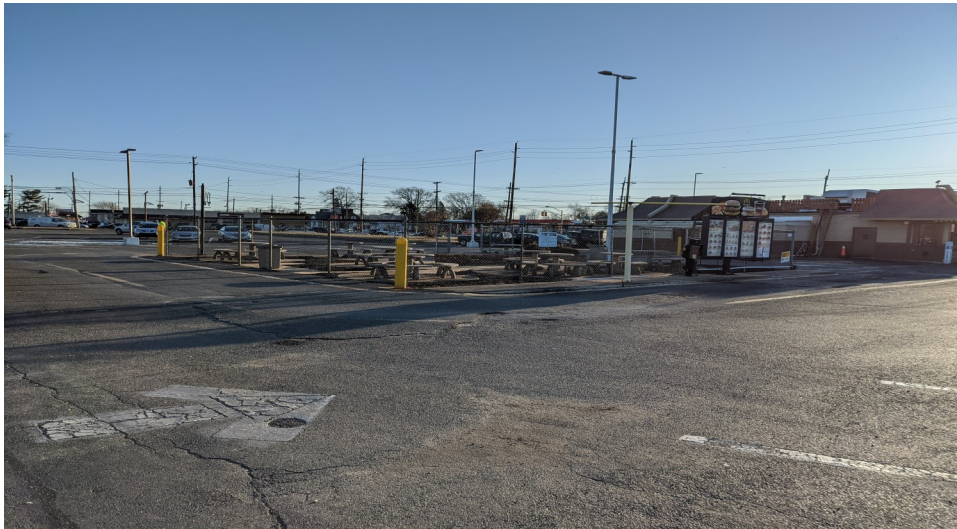
**LOT 13.02 RESTAURANT PARCEL, VIEW TO THE EAST/NORTHEAST.**
